AQUATIC CONSULTING & TESTING, INC.

Ref: Water Analysis October 7, 2013

Lake film identification

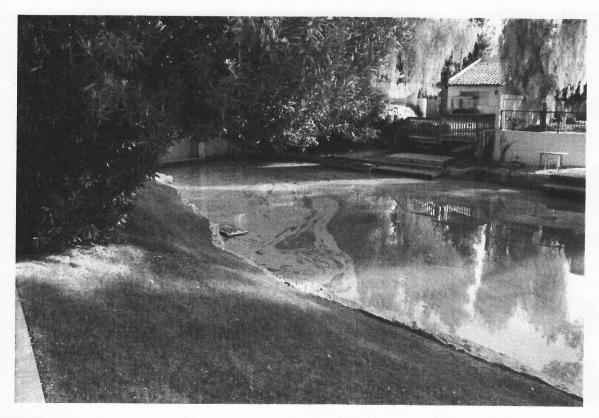
A follow up analysis in early December confirmed that reported scum on the lake surface was accumulated *Microcystis*. The colonies accumulated at the end of the lake system, immediately above the recirculation pumps. A resident-provided photograph is shown below.
